DART SERVICE INSTRUCTION

TO AMEND INSTALLATION INSTRUCTIONS D350-607-2 REV. C AND EARLIER,
INSTALLATION INSTRUCTIONS D350-607-3 REV. A AND EARLIER, AND
INSTRUCTIONS FOR CONTINUED AIRWORTHINESS ICA-D350-607 REV. 4 AND EARLIER

REF. TCCA STC: SH94-14

TITLE	SCALE
DE APPR.		WASHER CHANGE	NTS
DATE	13.06.06	COPYRIGHT © 2013 BY DART AEROSPACE LTD THIS DOCUMENT IS PRIVATE AND CONFIDENTIAL AND IS SUPPLIED ON THE EXPRESS CONDITION THAT IT IS NOT TO BE USED FOR ANY PURPOSE OR COPIED OR COMMUNICATED TO ANY OTHER PERSON WITHOUT WRITTEN PERMISSION FROM DART AEROSPACE LTD.

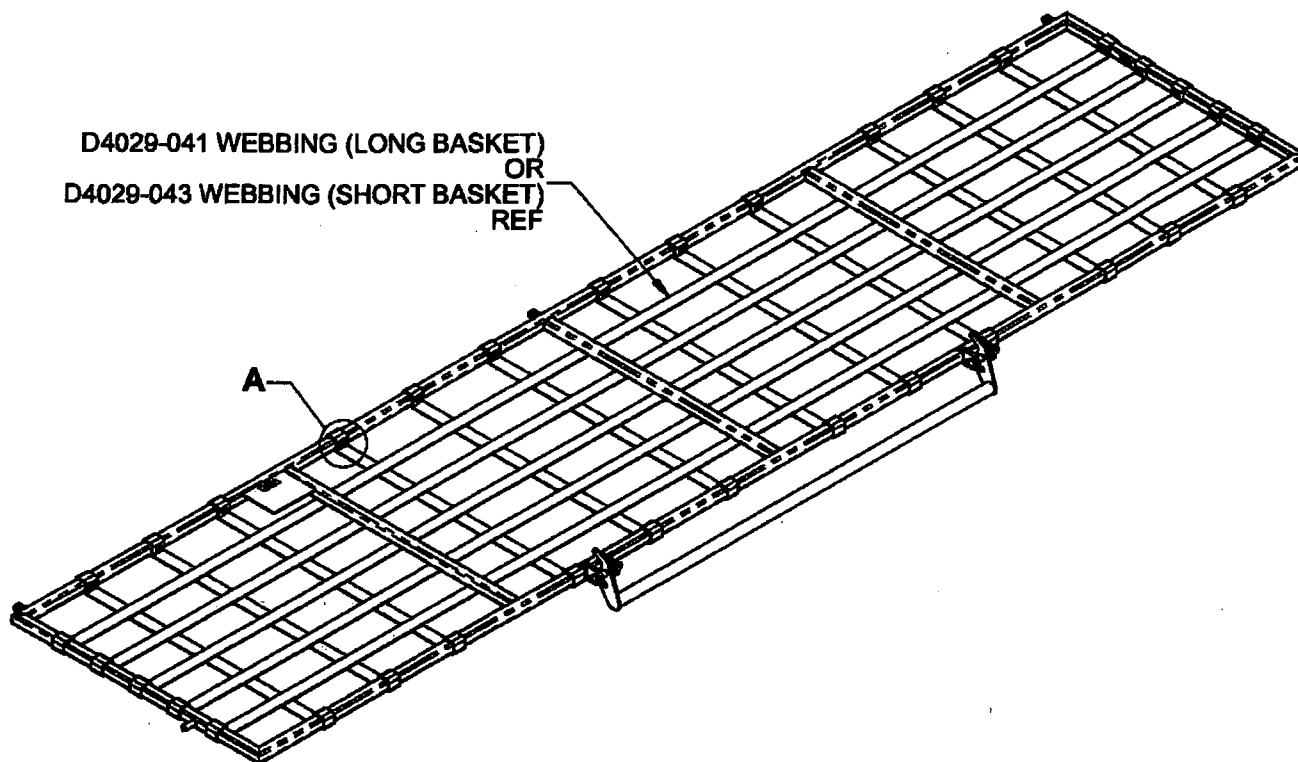
**FIGURE 1: D3915-041 LONG BASKET LID ASSY (LIGHT WEIGHT)
D4019-041 SHORT BASKET LID ASSY (LIGHT WEIGHT)**

It has come to DART's attention that the webbing strands of the cargo net riveted to the structure of the lightweight lids on D350-607-443/-447/-543/-547 Heli-Utility-Baskets at CHG 004 and earlier may pull through the small washer and rivet head and detach during operation.

2.1 Carefully remove existing rivets and washers attaching the webbing to the lid frame without enlarging holes in the webbing or the lid frame.

2.3 Inspect the D4029-041 Webbing (long basket) or D4029-043 Webbing (short basket) for wear. The maximum acceptable hole size is Ø0.188" (4.8 mm). Replace the webbing if holes are larger than Ø0.188" (4.8 mm) or if the webbing is worn or cuts have been found.

2.4 Re-install the webbing as shown in Figure 1 of this service instruction
